Failure Analysis of Bearings in Air Conditioning Compressor

Abstract

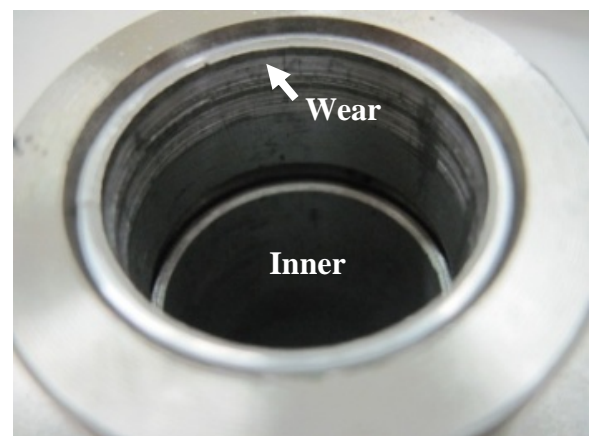
All journal bearings were failed in service. The wear sign was observed at the internal surface of both bearings as shown in Figure 1.

Figure 1: The observation of bearing worn in service.

The wear area was observed at inner surface of bearing as shown in the Fig.1. The surface damage appearing as scoring was found in many perimeter of inner surface. However, there were no cracking and contaminated particles observed.

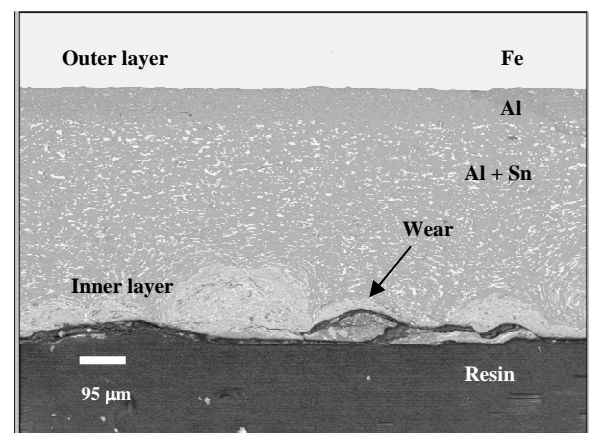
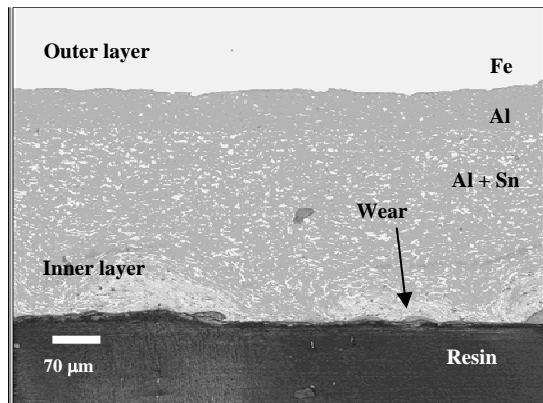
Figure 2: Microstructure in cross section of bearing 382 : a) Compliant
b) Orbiting

The wear sign was found in the homogeneous Al-Sn phase (bright zone near wear sign).

The lack of oil lubricant is the main reason for the wear found at the bearing in service. It led to the transformation of Al-Sn solution due to the increasing temperature till to melting point of alloy.

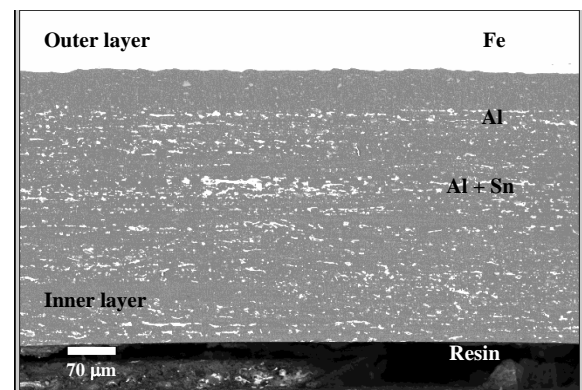
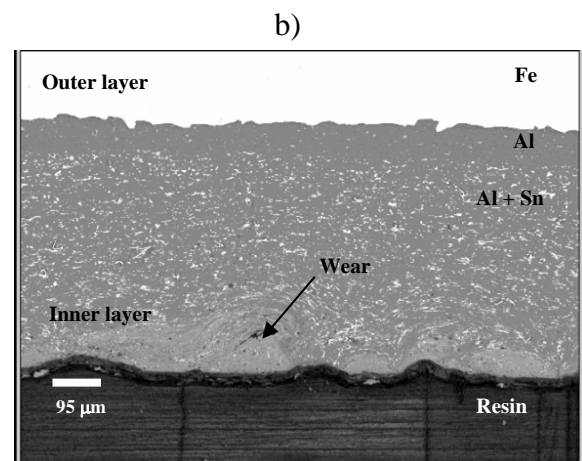
Figure 4: Microstructure in cross section of compliant bearing a) A22W-new b) A22W-oil c) A22W-no-oil.

Comparing to the unused, regularly used bearing, and bearing without lubrication (Figure 4a, 4b, 4c), Figure 4a and 4b show that no wear sign was observed at the Al-Sn layer. Contrarily, with the lack of oil, the microstructure of bearing in service (382 and 208) was similar to that in condition without oil lubrication.

The microstructures of bearings (382 and 208) in service were identical to that of A22W without oil lubrication. It can be firstly assumed that they may be in the same condition.

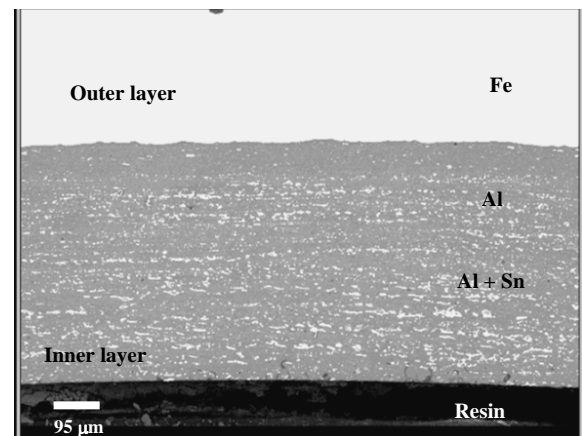
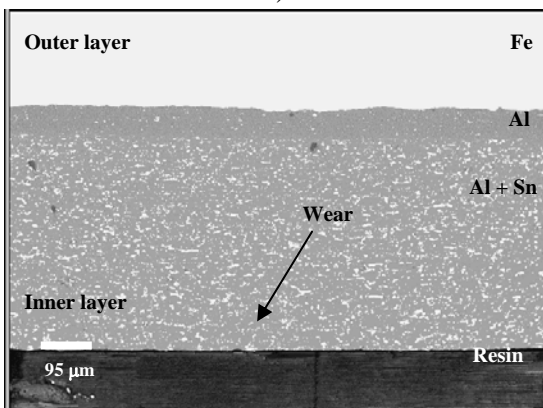
Figure 3: Microstructure in cross section of Bearing 208 : a) Compliant
b) Orbiting

From the Figure 3, the microstructure of bearing 208 was similar to that of 382. The wear sign was also found in the homogeneous Al-Sn phase.

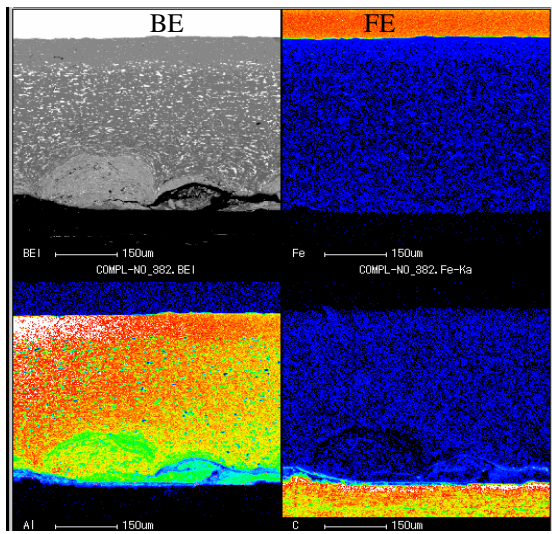
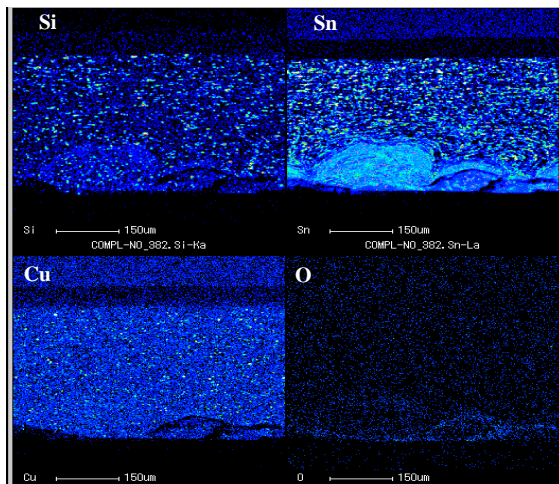
Figure 5: Elements distribution analysis of compliant bearing 382 by WDS mapping.

It was found that the bearing consisted of mainly 2 layers: outer and inner layers as shown in the figure 2, 3 and 4. According to WDS mapping analysis as depicted in Figure 5, the outer one composed mainly of Fe was used as the external bearing. In the other hands, the inner one consisted of the Al-Sn alloy. It was also composed of Sn precipitation distributed in entire coating layer. In addition, the interaction phase, as called bonding layer, consisted of mainly Al.
