## **EFFECT OF HIP PARAMETERS ON MICROSTRUCTURAL REPAIR AND REJUVENATION IN LONG-TERM SERVICED SUPERALLOY TURBINE BLADE, IN-738**

**Panyawat WANGYAO<sup>1\*</sup>, Sahathep JOYPRADIT<sup>2,3</sup>, Pongsak TUENGSOOK<sup>2</sup>,  
Veerasak HOMKRAJAI<sup>3</sup> and Srichalai KHUNTHON<sup>1</sup>**

<sup>3</sup> **Electricity Generating Authority of Thailand (EGAT), Nonthaburi, THAILAND**

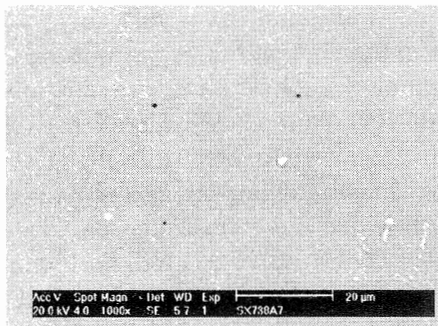
The SEM observation of all specimens after long-term service was supposed to confirm the progress of internal voids, as shown in Figures 1-4. The SEM analysis of unetched specimens shows the presence of micro-voids locating both in the matrix and at the carbides, which had been developed during service under long-term stress and temperature. The diameter size and amount of micro-voids depends on the location of the turbine blade. It was found that the zone of the airfoil tips, upper parts of the turbine blade, consist of the more and bigger diameter size of micro-voids. This was because the effect of much higher temperature took place during operation causing a higher rate of diffusion for internal void nucleation and growth.

**Figure 1** Microvoids locating in matrix.

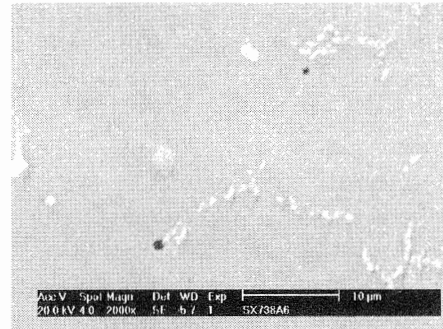
**Figure 2** Microvoids locating at carbides.

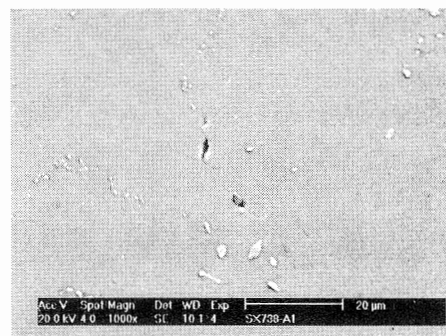
**Figure 3** Microcracks locating in matrix.

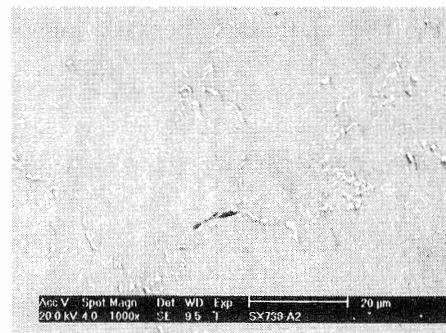
**Figure 4** Microcracks locating at carbides.

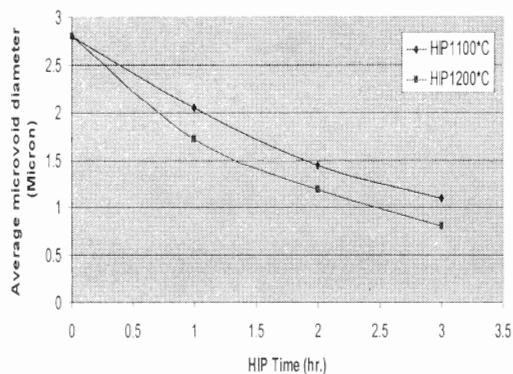
However, after the HIP process in all testing conditions, it should be noted that the HIP parameters such as temperature and time have a great effect on the efficiency of internal void sintering, see Figure 5. The process temperatures were selected so that the alloy yielded or crept in compression under the action of the applied pressure. The result is elimination of internal voids (porosity) and/or microcracks as well as nearly full densification

**Figure 5** The relationship between internal void diameter and HIP time.

Furthermore, the amount of internal voids (micro-voids) is also dependently decreased by an increase in HIP temperature and time. However, from Figure 5, it should be noted that the internal void closing rate at the earlier stage (0-1 hr.) is a bit faster than that of the middle (1-2 hr.) stage. The last (2-3hr.) stage has a rate of internal void closing a bit slower than that of the middle one. This seems that the efficiency of the HIP process to close the internal void decrease when the period of HIP time increased continuously. Followed by standard heat treatment after HIP programs of No. 3 and No. 6, it was found by SEM investigation that the microstructural homogeneity is clearly increased, Figures 6 and 7. It can be seen by comparing the size and morphology of the gamma prime between the initial state (as-received material after long-

As it can be seen from Figure 5, the final internal void diameter, after HIP at 1200°C for 3 hours, was not zero or very close to zero yet. It means that there are few very small micro voids still found inside the material so it might be recommended that it would be better to continue this HIP research program for longer HIP times such as for 4 and 5 hours and a higher of pressure (such as 120-130 MPa) in the future to completely close any microvoid.

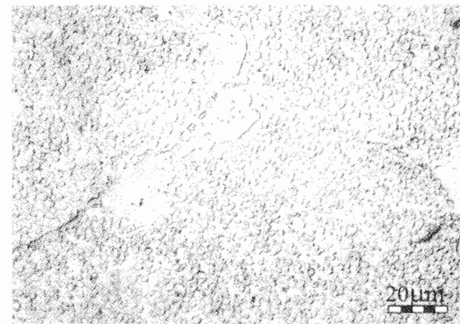
**Figure 6** Microstructure before HIP process.

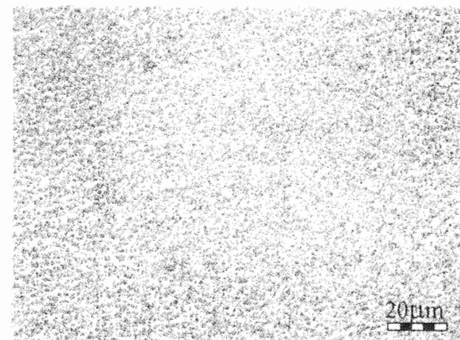
**Figure 7** Microstructure after HIP and Heat treatment.
