## Failure analysis of superheat tube 2.25Cr-1Mo in biomass power plant

### Abstract

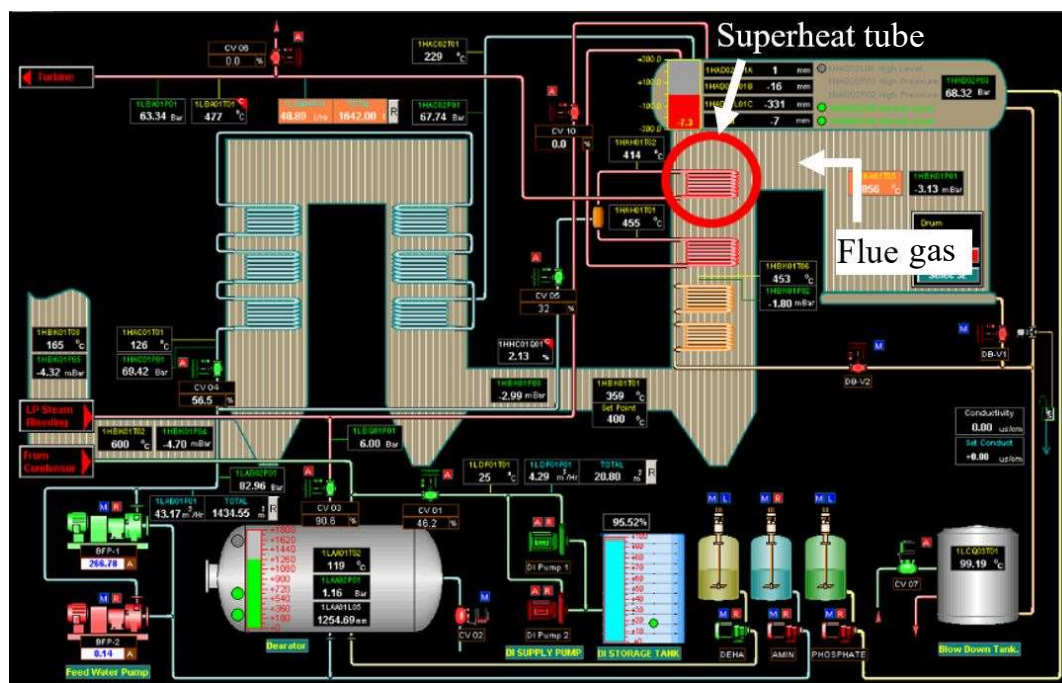
Figure 1. Location of failed tube in a biomass power plant.

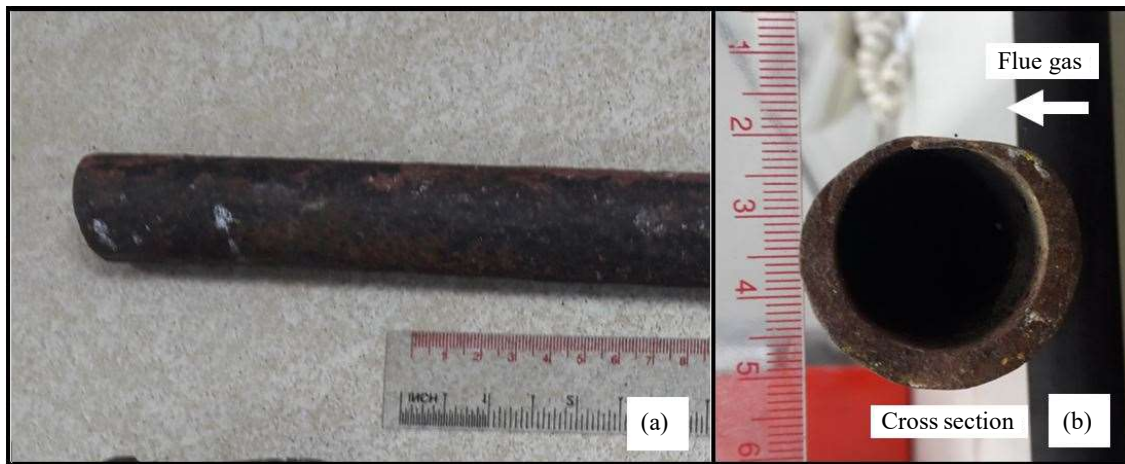
**Figure 2.** A sample cut from a failed superheat tube (a) overview, (b) cross section of tube.

As shown in Figure 2, damages are apparent on the external tube surface especially at the fireside whose

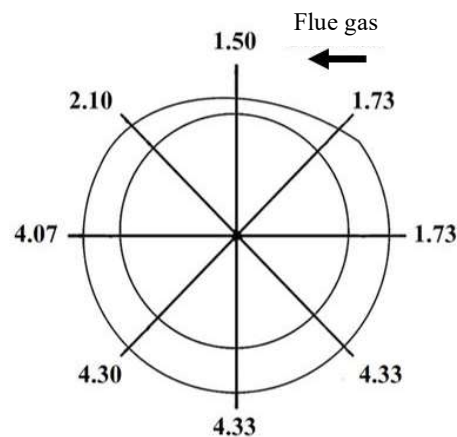
wall thickness was found to be less than 2.5 times the opposite side (Figure 3). This is a result of flue gas impingement at the temperature of around  $850^\circ\text{C}$ . The particles of rice husk and chopped wood mixing with the flue gas scratched the external tube surface, commonly known as fly-ash erosion, and this finding is similar to the studies of Das [22] and Pronobis [23]. The fly ash erosion with the different impinging angles is anticipated to cause the non-uniform tube thickness. Erosion is usually occurred in the biomass boiler. The increased amount of ash particles in the flue gas stream can decrease the thickness of boiler tube and in turn leads to a rupture. The increase in particle velocity exponentially increases the erosion rate. Moreover, the impinging angle, size and shape of the particles play a vital role in the surface erosion [24,25]. The erosion rate substantially increases when the particle size of larger than  $30 \mu\text{m}$  strikes the surface. The large amount of solid particles in the gas typically increases the erosion rate, but this effect may be imperceptible when the amount of particles is of very high [26]. Furthermore, the severe erosion is evidenced when the particle size is equal to  $1000 \mu\text{m}$  [27].

**Figure 3.** Wall thickness of failed tube (unit in mm).

The greatest erosion occurs when using non-spherical particles with sharp edges and high hardness. The maximum tube erosion is apparent at the impinging angle of approximately 40 degrees to the axis of the flue gas stream [28]. According to the sample, the wall thickness was reduced approximately by 74% on the fireside, where it was attacked at the high temperature of flue gas and fly ash particles. In addition, the tube burst was found in the longitudinal direction.

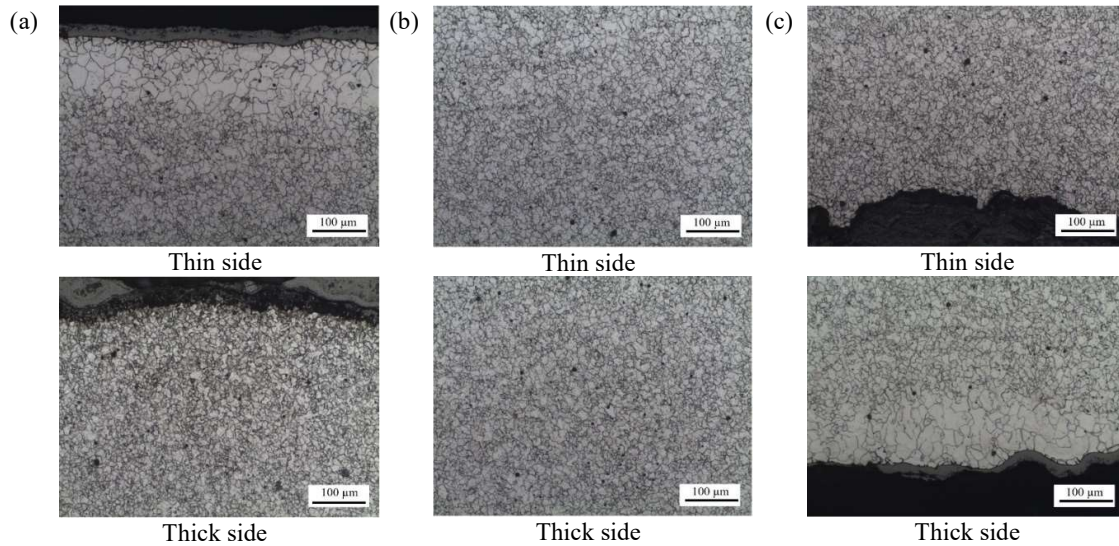
(dark area), while the failed tube was subjected to phase transformations. As mentioned in the Figure 7, the heated tube was in recovery status. The stored internal energy was relieved, as a result of enhanced atomic diffusion at the elevated temperature. After recovery was complete, the grains are still in a relatively high strain energy state. The new set of strain-free and equiaxed grains were formed, known as recrystallization process. The driving force to produce this new grain structure is the difference in internal energy between the strained and unstrained material. The new grains form as very small nuclei and grow until they completely consume the parent material [29].

**Figure 7.** Microstructures of failed tube (a) outside (b) mid-wall (c) inside.

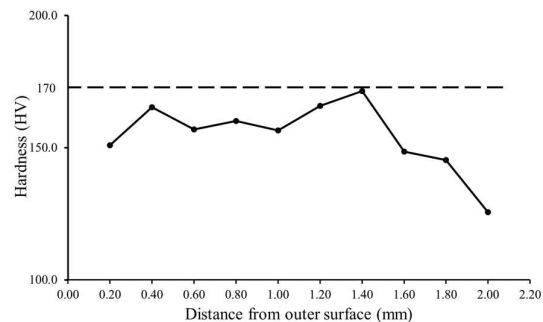
The micro-hardness was performed on the thin side (fireside) and compared to the average hardness of the virgin tube. The hardness was measured from the inner surface (steam side) to the outer surface (fireside) with the total of 10 points. The results shown in Figure 8 indicated that the average micro-hardness of the virgin tube was 170 HV (~163 HBN max), while the minimum and maximum values of hardness at the inner surface were 125.6 HV and 171.5 HV, respectively. The hardness was found to reduce both on fire side and steam side due to the long time heating. The hardness of steam side was lower than the fireside due to the small amount of coagulated carbides. The hardness reduction of failed tube could also be a consequence of the microstructural changes; i.e. formation of new grain particle, dissolution of pearlite and carbide formation [30].

**Figure 8.** Micro-hardness at different distances from the inner surface.

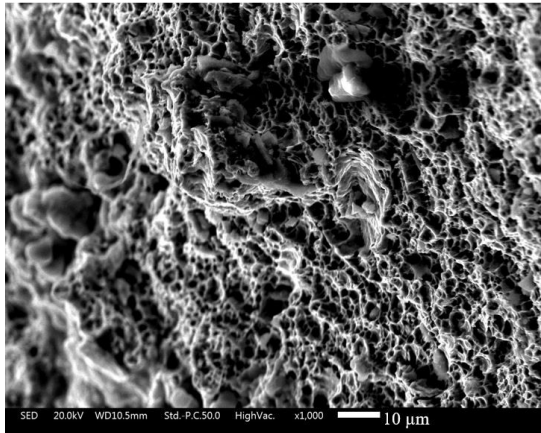
The characteristic of damage area was investigated by using SEM. From the SEM result shown in Figure 9, the microstructure at the burst region was stretched associated with ductile tube fracture.

Figure 9. SEM micrograph of damage region.

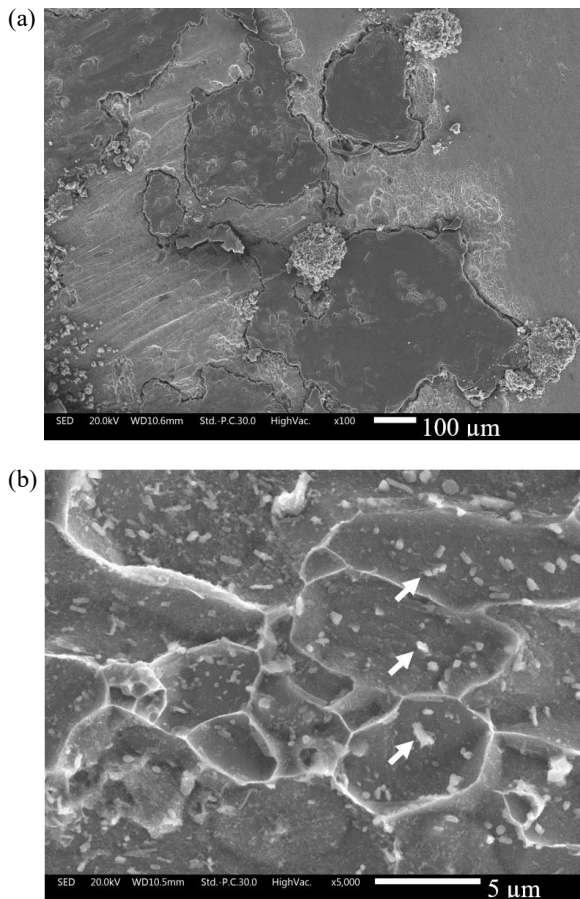
The external fireside was investigated. A high magnification image taken by SEM is presented in Figure 10, demonstrating the new grain particles (indicated by arrows) and carbides at the grain boundaries.

Figure 10. SEM micrograph of external surface (a) corrosion area, (b) grain boundary.
