# Atmospheric corrosion of hot dip galvanized structural steel exposed to the tropical climate of Thailand

Adithep BUNPHOT<sup>1,\*</sup>, Pakawat SANCHAROEN<sup>1</sup>, Somnuk TANGTERMSIRIKUL<sup>1</sup> and Taweep CHAISOMPJOB<sup>1</sup>

<sup>1</sup> Sirindhorn International Institute of Technology, Thammasat University, Pathum Thani, 12120, Thailand

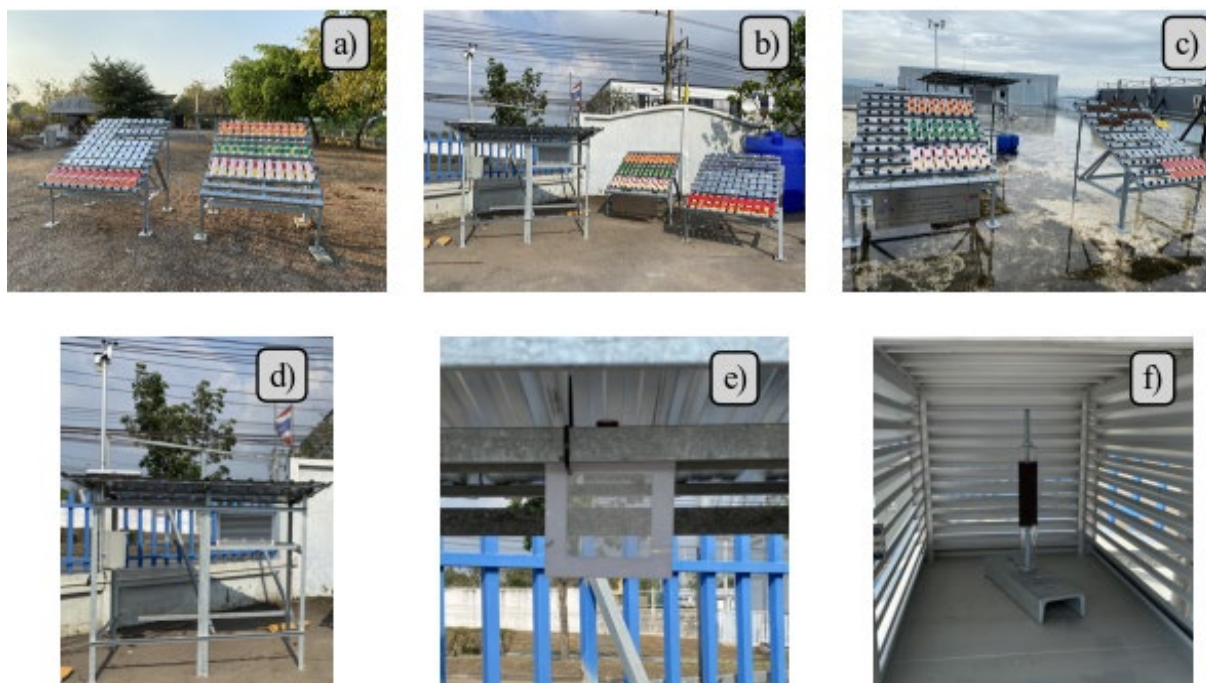
**Figure 1.** the test setup at Saraburi a), Chonburi b), and Songkhla c) together with the weather station d), dry gauze e) and lead cylinder f).

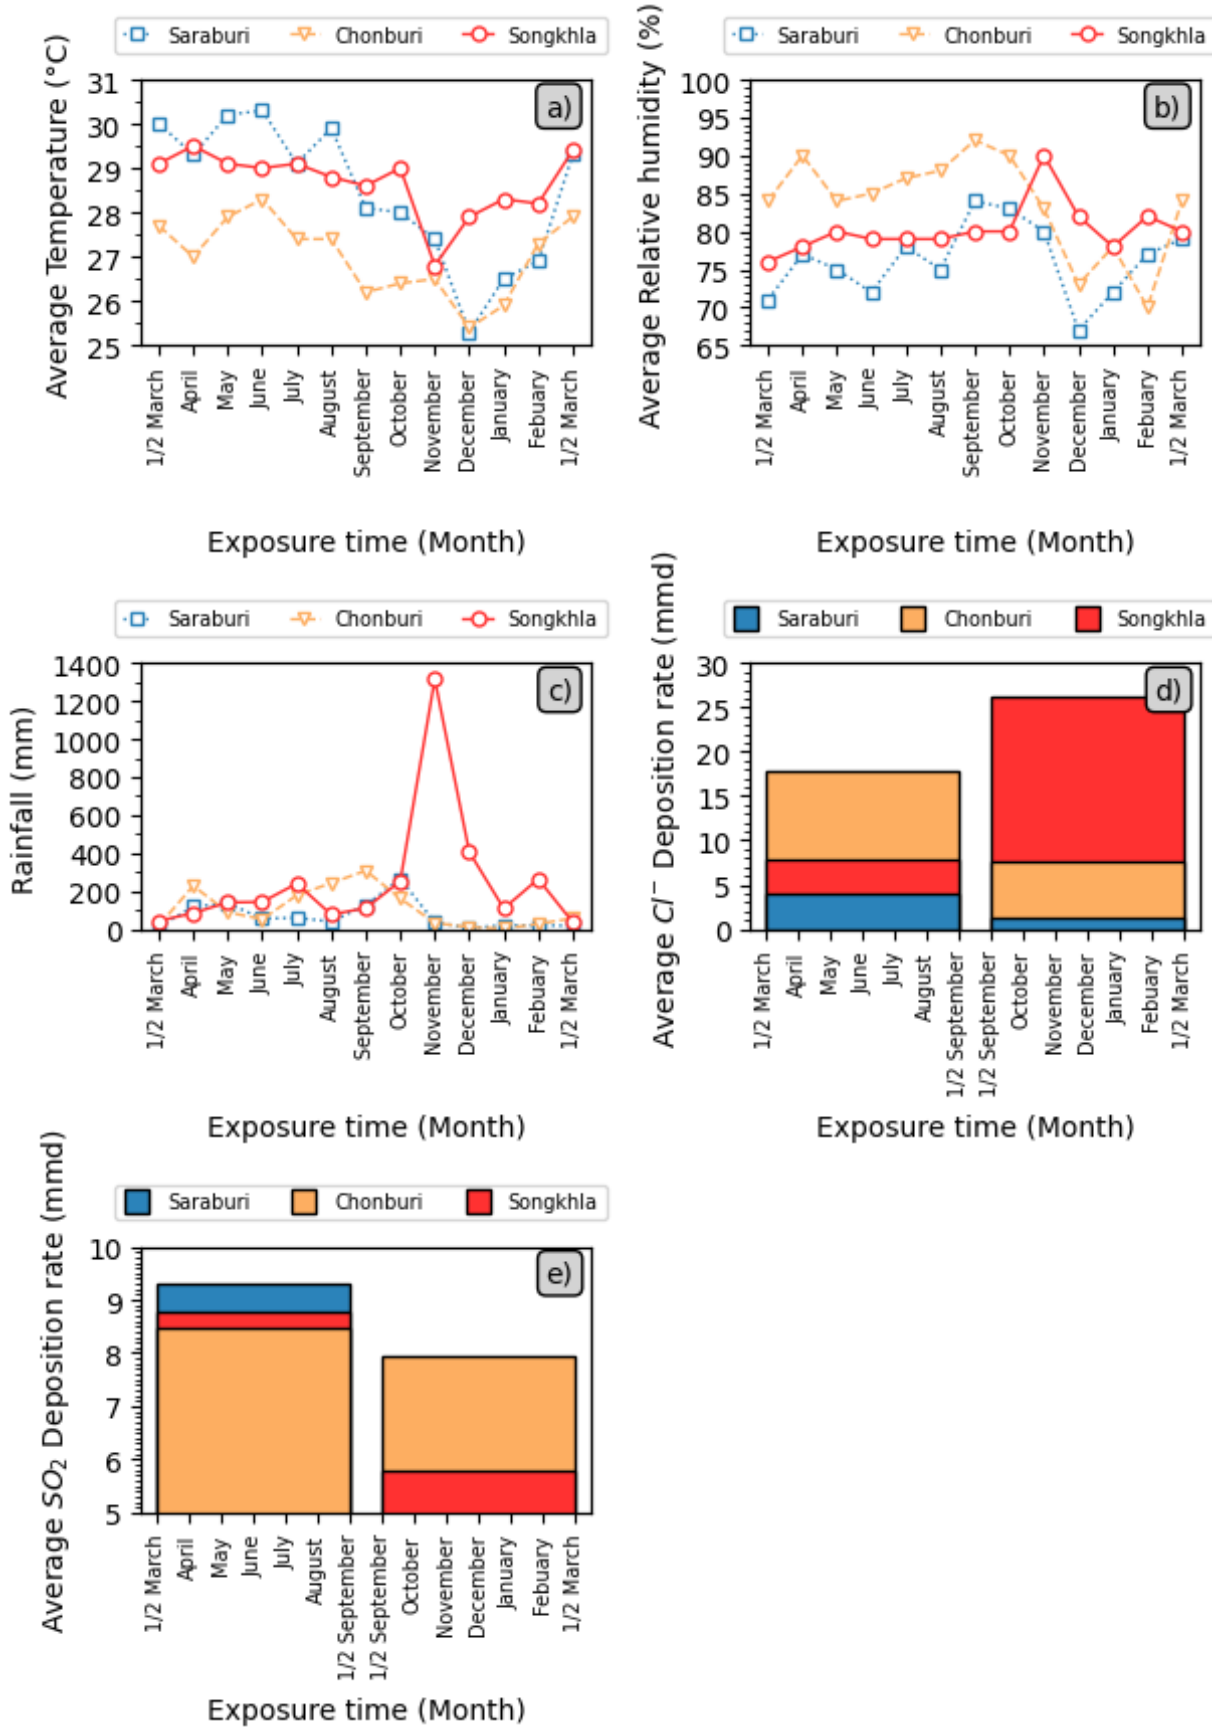
Figure 2. Environmental conditions at the stations; Average temperature (a), Average relative humidity (b), Rainfall (c), Average Cl<sup>-</sup> deposition rate (d), and Average SO<sub>2</sub> deposition rate (e).

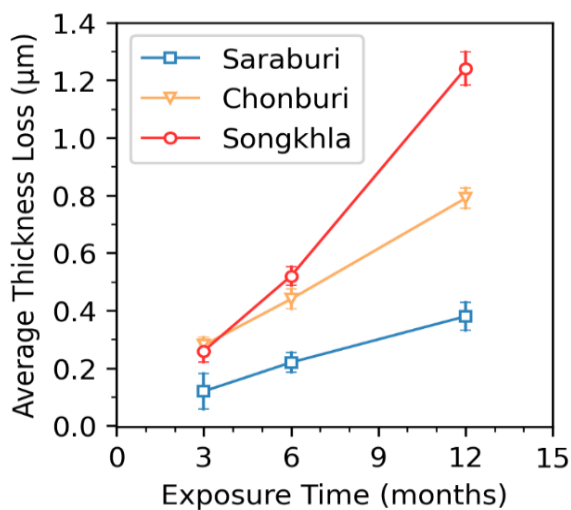
**Figure 4.** Average thickness loss of the galvanized steel samples exposed at Saraburi, Chonburi, and Songkhla.

where  $C$  is the thickness loss ( $\mu\text{m}$ ),  $W$  is the sample weight loss (g),  $\rho$  is the density of zinc ( $7.14 \text{ g}\cdot\text{cm}^{-3}$ ), and  $A$  is the sample exposure surface area ( $\text{cm}^2$ ). The results are shown in Figure 4. It can be seen that Songkhla has the highest thickness loss, followed by Chonburi and then Saraburi. This is because the rainfall and Cl<sup>-</sup> deposition rate were found to be the highest at Songkhla and the lowest at Saraburi, where Chonburi was in the middle as shown in Table 2. The thickness loss at Chonburi and Saraburi showed a similar pattern compared to

Songkhla, which is related to the country’s seasonal monsoon. Both stations received the maximum amount of rainfall from July to October, which corresponds to the 4<sup>th</sup> to 7<sup>th</sup> month of the exposure test. In this period, the southwest monsoon carried moisture from the Gulf of Thailand to precipitate on lands in the central, eastern, and potentially northeastern parts of Thailand. Following this interval, the stations remained dry most of the time until March, which corresponds to the 12<sup>th</sup> month of the exposure test. During this dry period, the thickness loss at the stations increased at a slow rate. In the case of Songkhla, the station received the maximum amount of rainfall from October to February, which corresponds to the 7<sup>th</sup> to 11<sup>th</sup> month of the exposure test. In this period, the northeast monsoon carried moisture from the Gulf of Thailand to precipitate on lands in the southern part of Thailand, causing the thickness loss at the station to increase at a drastic rate. Furthermore, the monsoons possibly brought more airborne salt to the stations as the Cl<sup>-</sup> deposition rates were recorded higher during the first six months compared to the second six months at Chonburi and Saraburi, while the rates were recorded higher during the second six months compared to the first six months at Songkhla. Such an observation where rainfall is a contributor to thickness loss of the galvanized steel was reported in Mexico due to the zinc runoff effect [11]. Zinc ions are released and dispersed into the environment from the corrosion product film and the coating surface bulk. Especially during the first rain event after some dry periods, the first flush, the ions get released significantly [11,12]. Velva et al also reported that 63% to 87% of the total corrosion weight loss of the galvanized steel was due to this effect in Mexico [13]. In this research, SO<sub>2</sub> was found to be insignificantly related to thickness loss. Normally, SO<sub>2</sub> is the cause of acid rain in the environment. However, it was found in particular that acid rain in Thailand is not likely to occur due to the neutralizing effect of the NH<sub>4</sub>:SO<sub>4</sub> ratio found in the rainwater [14]. Temperature and relative humidity were also observed to be insignificant to the thickness loss. Comparing the 12<sup>th</sup>-month thickness loss result of each station in this research, which is the first-year corrosion rate to the first-year corrosion rate predicted by the existing corrosion map introduced by MTEC, the map provides 50% greater corrosion magnitude at Saraburi and Chonburi and 80% greater corrosion magnitude at Songkhla [4]. Despite the large differences in the corrosion magnitude, the map still provides an agreeable result based on two reasons. The first reason is primarily due to large historical data

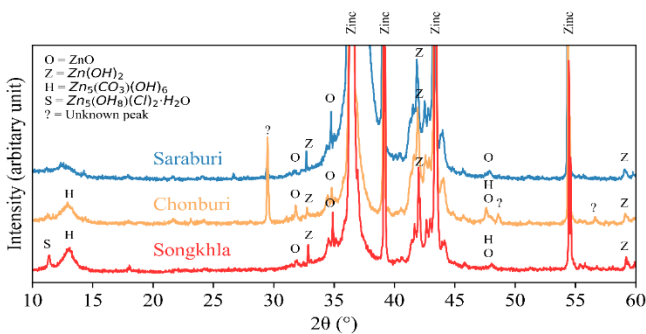
**Figure 5.** X-ray diffractogram of corrosion products on the galvanized steel samples exposed at Saraburi, Chonburi, and Songkhla for 12 month..

Figure 5. shows the characterization of corrosion products on the samples at Saraburi, Chonburi, and Songkhla. Because the samples were too big to fit inside the equipment, they were cut into smaller samples of 20 mm × 20 mm from the center of the original corroded samples. Before cutting, they were covered with a plastic wrapper to prevent dust contamination. The figure only shows the 12<sup>th</sup>-month results, as it was unable to conduct the test in the 3<sup>rd</sup> month and 6<sup>th</sup> month because the samples still had a low amount of corrosion products. Due to the lower amount of corrosion products, their peak sets were only found near the base of the original zinc peaks, which are definitely from the zinc coating bulk itself. Also, a single unknown peak set was detected on the sample at Chonburi. Some of its peaks might be located inside other corrosion product peaks, which made the total peak set unidentifiable. Beside the unidentifiable peak set, peak sets of ZnO (Zincite), ε-Zn(OH)<sub>2</sub> (Wulfingite), Zn<sub>5</sub>(CO<sub>3</sub>)<sub>2</sub>(OH)<sub>6</sub> (Hydrozincite), and Zn<sub>5</sub>(OH)<sub>8</sub>(Cl)<sub>2</sub>·H<sub>2</sub>O (Simonkolleite) were detected on the samples. The summary is presented in Table 4. These corrosion products appear to be common for the galvanized steel exposed in tropical climate countries, in which they are known for hot and humid features [2,3]. Based on the results, the progression of corrosion products together with environmental parameters is expected as Zincite → Wulfingite → Hydrozincite, or Simonkolleite. Zincite is likely to be the initial corrosion product that develops on the samples as it requires only zinc and some oxygen in the atmosphere to be formed. When the oxide is exposed to moisture, it can transform into several types of Zn(OH)<sub>2</sub> (Zinc Hydroxide). In this study, it was found to be ε-Zn(OH)<sub>2</sub>. The hydroxide is later used as a seed crystal to form other hydrozincite and simonkolleite as follows [17]:
