# Atmospheric corrosion of hot dip galvanized structural steel exposed to the tropical climate of Thailand

Atmospheric corrosion; Atmospheric exposure test; Hot dip galvanized steel

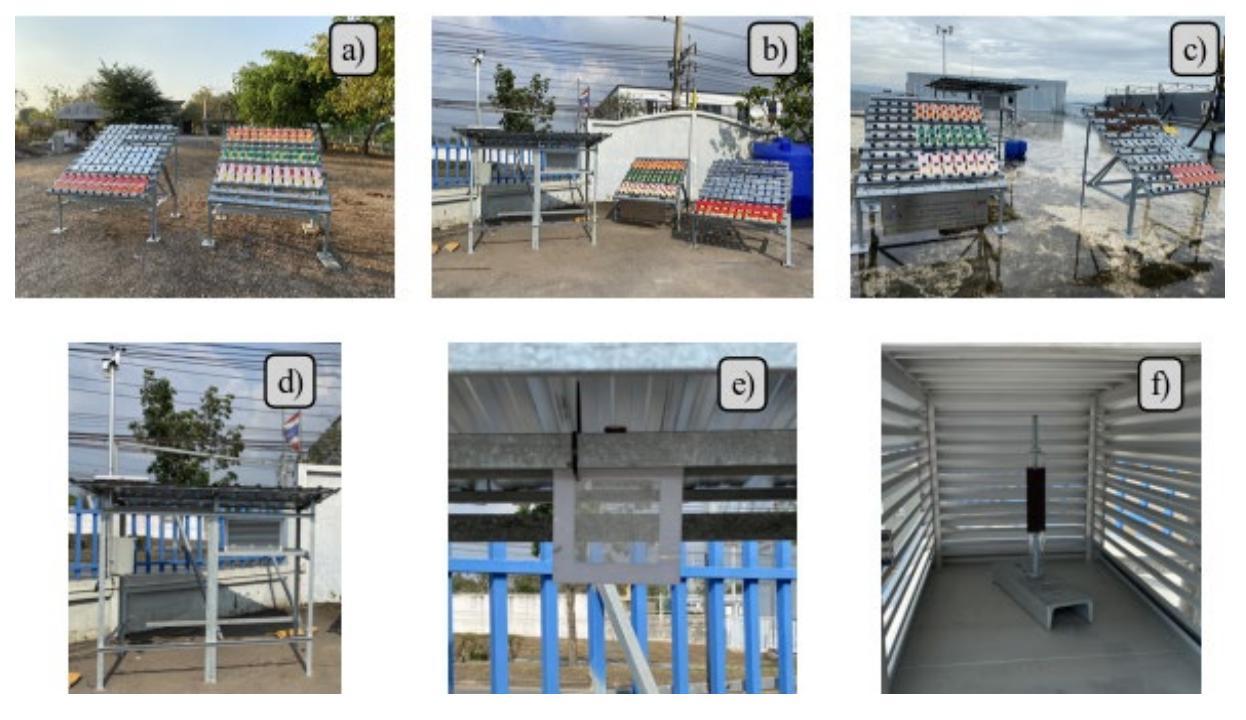
Figure 1. the test setup at Saraburi a), Chonburi b), and Songkhla c) together with the weather station d), dry gauze e) and lead cylinder f).

in Table 1 from the spark emission spectroscopy. Their galvanized coating thickness was measured between 90 µm to 100 µm. At Saraburi station, the test was conducted on the ground in a private residential area near rice fields (rural area) in the central part of Thailand. At Chonburi station, the test was conducted on the ground at a galvanizing factory in the WHA industrial estate (industrial area) in the eastern part of Thailand. Lastly, at Songkhla station, the test was conducted on top of a building at Rajamangala University in the city of Songkhla, near Samila Beach (urban/coastal area) in the southern part of Thailand. The distances from the sea (the Gulf of Thailand) to each station are 110 km, 18 km, and 0.3 km for Saraburi, Chonburi, and Songkhla, respectively. Temperature, relative humidity, and rainfall at the stations were monitored monthly using a weather station. The Cl- dry deposition rate and SO<sub>2</sub> dry deposition rate were monitored every 6 month using the dry gauze and the lead cylinder according to ISO 9225. The surface of the galvanized steel samples was prepared according to ASTM G1. Before the exposure test, the samples were dry polished with silicon carbide paper number 120 followed by 600, rinsed with distilled water followed by acetone, dried by a blower, weighed, and put inside a desiccator. During the exposure test, the samples were mounted on the 30° exposure racks that were set facing toward the closest sea direction. Figure 1 shows examples of the test setup at the three stations together with the weather station, dry gauze, and lead cylinder. Environmental conditions at the stations during the exposure test are shown in Figure 2. In the figure, the Cl-values from the dry gauze were converted into the standard Cl- values by a multiplication factor of 2.4 [10]. Moreover, the SO2 value at Saraburi was missing for the second 6 month due to technical difficulties. After 3, 6, and 12 month, four samples were collected back from each station and sent to the laboratory for analysis. For each period, in each location, three collected samples were used immediately for the thickness loss analysis, and one collected sample was stored separately for later corrosion product and surface analysis. For thickness loss analysis, the thickness loss of the samples was calculated by the weight loss method. For corrosion products and surface analysis, the corrosion products were characterized using XRD technique with BRUKER diffractometer, and the micro surface appearances were studied using SEM and EDS with JEOL scanning electron microscope and Oxford Instrument energy dispersive spectroscopy.

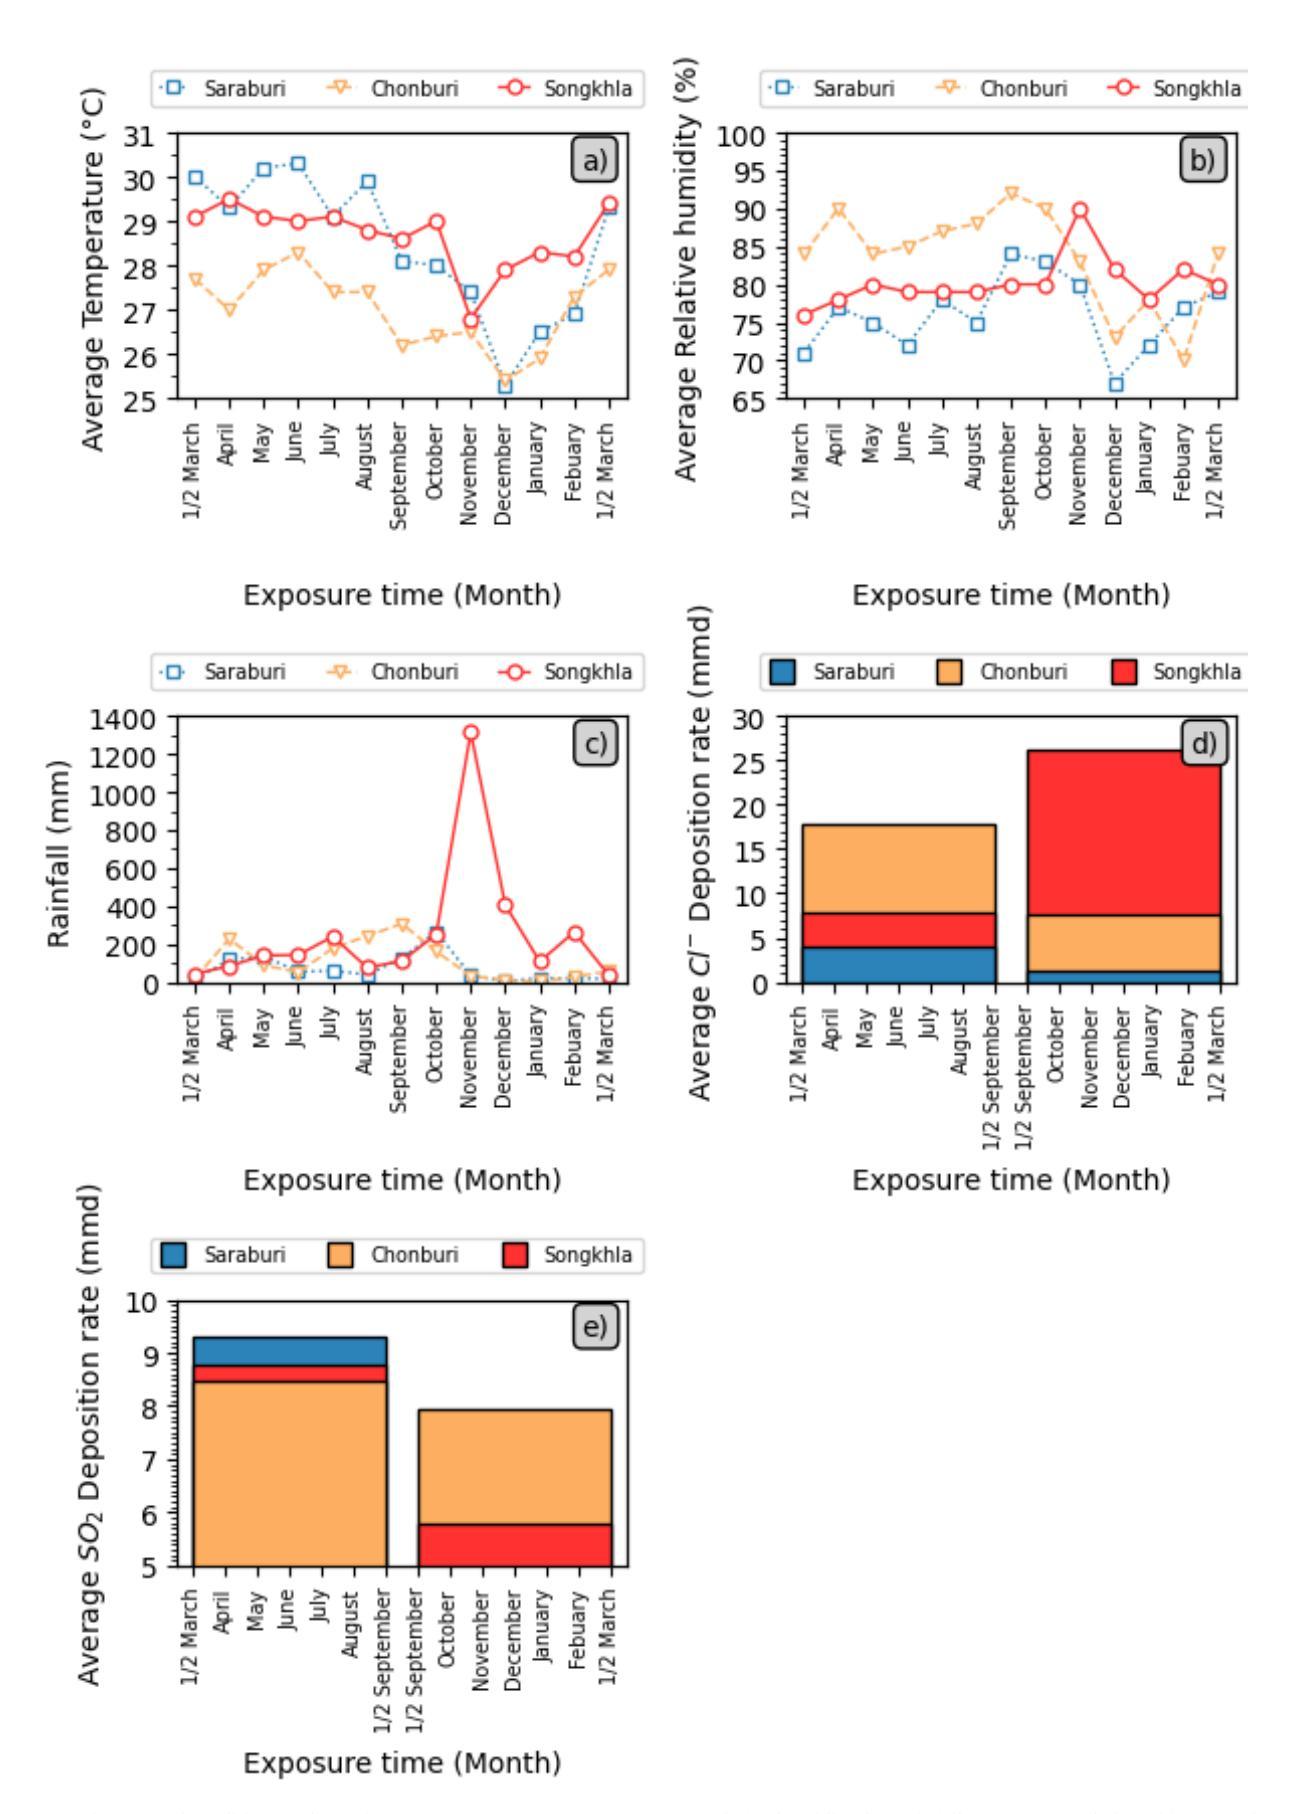
Figure 2. Evironmental conditions at the stations; Average temperature (a), Average relative humidity (b), Rainfall (c), Average Cl<sup>-</sup> deposition rate (d), and Average SO<sub>2</sub> deposition rate (e).

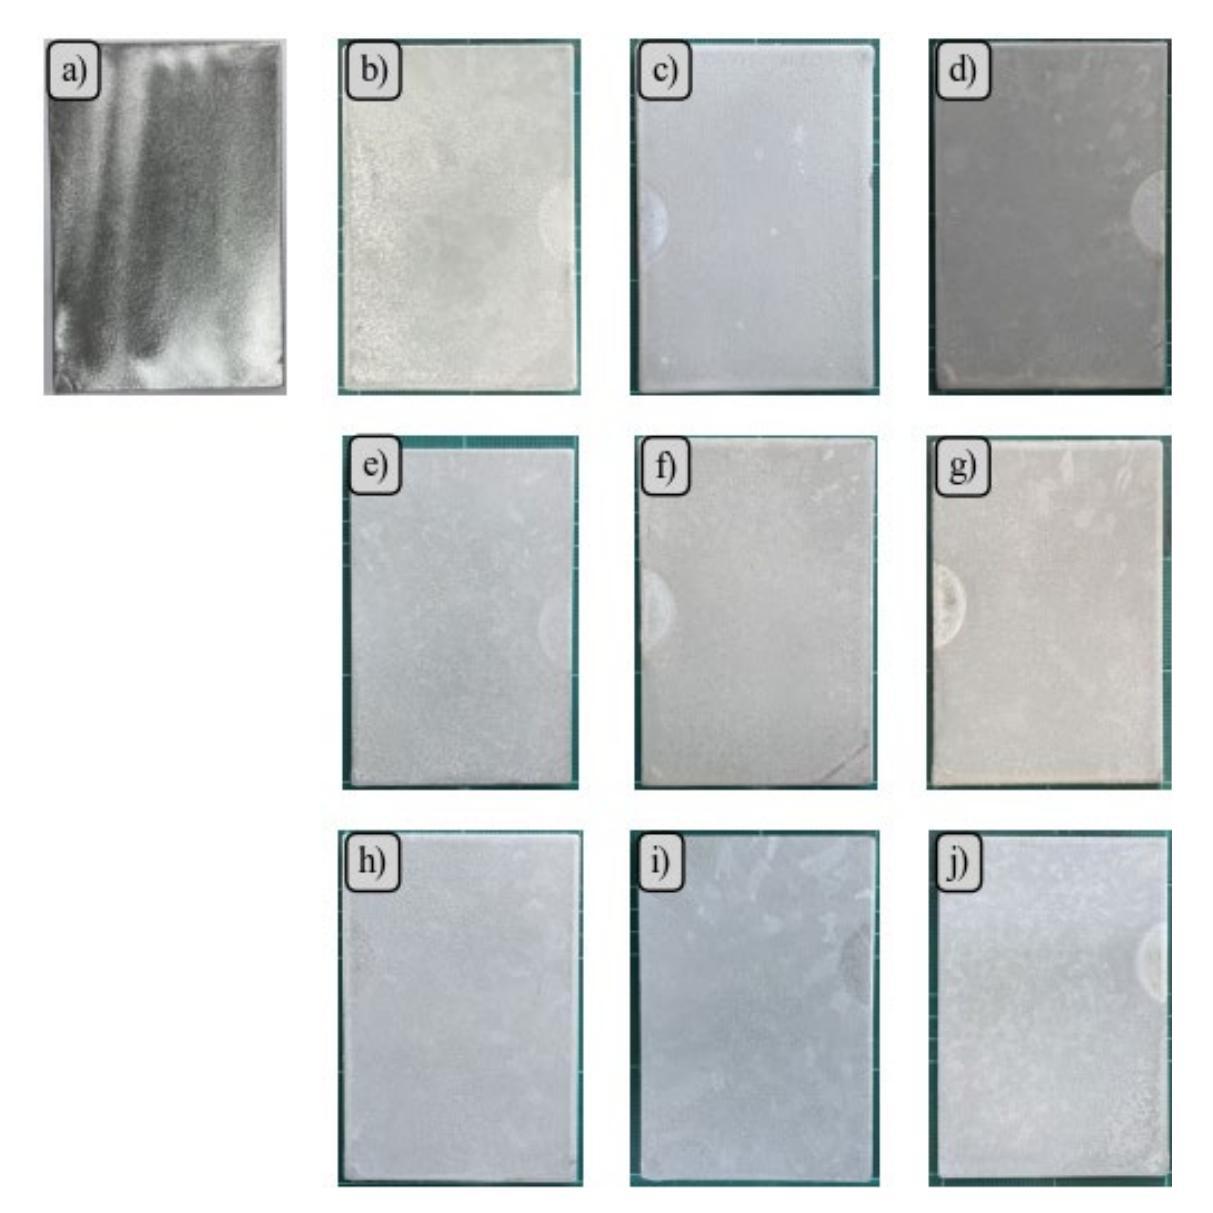
Figure 3. Surface appearances of galvanized steel samples; (a) before the exposure test, (b) to (d) after 3, 6, and 12 month of exposure at Saraburi, (e) to (g) after 3, 6, and 12 month of exposure at Chonburi, and (h) to (j) after 3, 6, and 12 month of exposure at Songkhla.

Figure 3 shows examples of the surface appearances of the galvanized steel sample before and after 3, 6, and 12 month for the exposure tests at Saraburi, Chonburi, and Songkhla, respectively. Before the exposure tests, the galvanized steel was bright and shiny. After the exposure test, the galvanized steel was blunt and dull. Corrosion products were visible in local areas rather than the entire surface. The 12<sup>th</sup>-month sample at Saraburi shows a darker surface appearance compared to the other two stations. This is due to dark depositions that covered the surface of the sample which can be removed mechanically. They possibly came from the seasonal burning of rice fields from local farmers near the station.

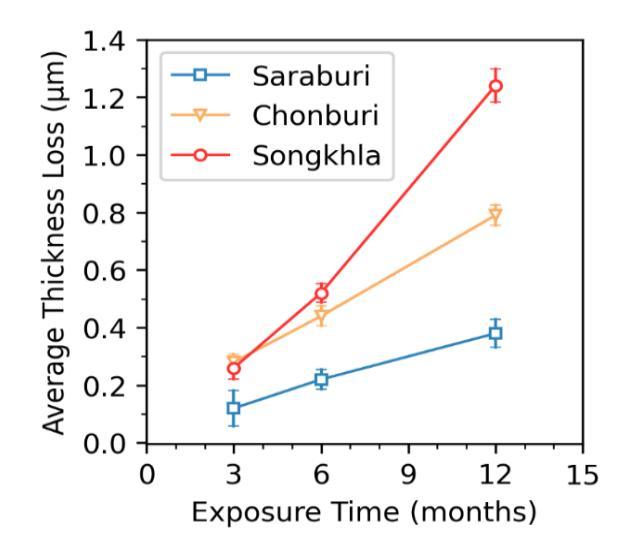
Figure 4. Average thickness loss of the galvanized steel samples exposed at Saraburi, Chonburi, and Songkhla.

where *C* is the thickness loss ( $\mu$ m), *W* is the sample weight loss (g),  $\rho$  is the density of zinc (7.14 g·cm<sup>-3</sup>), and A is the sample exposure surface area (cm<sup>2</sup>). The results are shown in Figure 4. It can be seen that Songkhla has the highest thickness loss, followed by Chonburi and then Saraburi. This is because the rainfall and Cl<sup>-</sup>deposition rate were found to be the highest at Songkhla and the lowest at Saraburi, where Chonburi was in the middle as shown in Table 2. The thickness loss at Chonburi and Saraburi showed a similar pattern compared to

Songkhla, which is related to the country's seasonal monsoon. Both stations received the maximum amount of rainfall from July to October, which corresponds to the 4th to 7th month of the exposure test. In this period, the southwest monsoon carried moisture from the Gulf of Thailand to precipitate on lands in the central, eastern, and potentially northeastern parts of Thailand. Following this interval, the stations remained dry most of the time until March, which corresponds to the 12<sup>th</sup> month of the exposure test. During this dry period, the thickness loss at the stations increased at a slow rate. In the case of Songkhla, the station received the maximum amount of rainfall from October to February, which corresponds to the 7th to 11th month of the exposure test. In this period, the northeast monsoon carried moisture from the Gulf of Thailand to precipitate on lands in the southern part of Thailand, causing the thickness loss at the station to increase at a drastic rate. Furthermore, the monsoons possibly brought more airborne salt to the stations as the Cl<sup>-</sup> deposition rates were recorded higher during the first six months compared to the second six months at Chonburi and Saraburi, while the rates were recorded higher during the second six months compared to the first six months at Songkhla. Such an observation where rainfall is a contributor to thickness loss of the galvanized steel was reported in Mexico due to the zinc runoff effect [11]. Zinc ions are released and dispersed into the environment from the corrosion product film and the coating surface bulk. Especially during the first rain event after some dry periods, the first flush, the ions get released significantly [11,12]. Velva et al also reported that 63% to 87% of the total corrosion weight loss of the galvanized steel was due to this effect in Mexico [13]. In this research, SO2 was found to be insignificantly related to thickness loss. Normally, SO<sub>2</sub> is the cause of acid rain in the environment. However, it was found in particular that acid rain in Thailand is not likely to occur due to the neutralizing effect of the NH4:SO4 ratio found in the rainwater [14]. Temperature and relative humidity were also observed to be insignificant to the thickness loss. Comparing the 12th-month thickness loss result of each station in this research, which is the first-year corrosion rate to the first-year corrosion rate predicted by the existing corrosion map introduced by MTEC, the map provides 50% greater corrosion magnitude at Saraburi and Chonburi and 80% greater corrosion magnitude at Songkhla [4]. Despite the large differences in the corrosion magnitude, the map still provides an agreeable result based on two reasons. The first reason is primarily due to large historical data of environmental parameters that are averaged and used as a source for the mathematical model to predict corrosion. It is possible that environmental parameters such as rainfall, temperature, and relative humidity might deviate significantly from the average during the exposure test period of this research. The second reason is the elevation related to the chloride deposition rate. This can be seen in the case of the exposure test at Songkhla. The test was conducted on top of a building later than on the ground near the beach. It is possibly due to the fact that the chloride deposition rate is much greater on the ground compared to on top of a building. Sea salt aerosol particles, SSA cannot possibly travel much high from the ground elevation. Bongochgetsakul *et al.* report this behavior of SSA using watersensitive paper. Particle size and particle distribution are larger and denser at 1 m from the ground compared to 4 m at a sand beach [15].

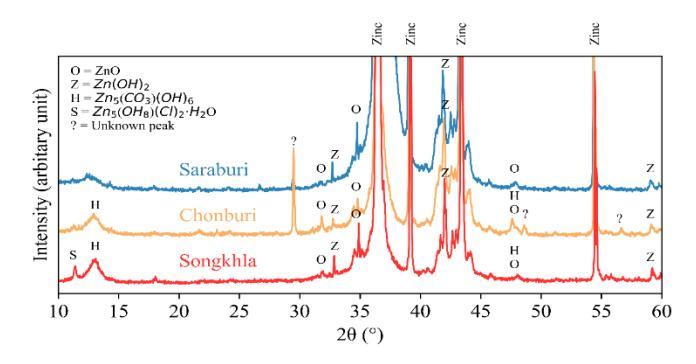
Figure 5. X-ray diffractogram of corrosion products on the galvanized steel samples exposed at Saraburi, Chonburi, and Songkhla for 12 month..

Figure 5. shows the characterization of corrosion products on the samples at Saraburi, Chonburi, and Songkhla. Because the samples were too big to fit inside the equipment, they were cut into smaller samples of 20 mm × 20 mm from the center of the original corroded samples. Before cutting, they were covered with a plastic wrapper to prevent dust contamination. The figure only shows the 12th-month results, as it was unable to conduct the test in the  $3^{rd}$  month and  $6^{th}$ month because the samples still had a low amount of corrosion products. Due to the lower amount of corrosion products, their peak sets were only found near the base of the original zinc peaks, which are definitely from the zinc coating bulk itself. Also, a single unknown peak set was detected on the sample at Chonburi. Some of its peaks might be located inside other corrosion product peaks, which made the total peak set unidentifiable. Beside the unidentifiable peak set, peak sets of ZnO (Zincite), ɛ-Zn(OH)2 (Wulfingite), Zn5(CO)3(OH)6 (Hydrozincite), and Zn5(OH)8(Cl)2·H2O (Simonkolleite) were detected on the samples. The summary is presented in Table 4. These corrosion products appear to be common for the galvanized steel exposed in tropical climate countries, in which they are known for hot and humid features [2,3]. Based on the results, the progression of corrosion products together with environmental parameters is expected as Zincite  $\rightarrow$ Wulfingite → Hydrozincite, or Simonkolleite. Zincite is likely to be the initial corrosion product that develops on the samples as it requires only zinc and some oxygen in the atmosphere to be formed. When the oxide is exposed to moisture, it can transform into several types of Zn(OH)<sub>2</sub> (Zinc Hydroxide). In this study, it was found to be ε-Zn(OH)<sub>2</sub>. The hydroxide is later used as a seed crystal to form other hydrozincite and simonkolleite as follows [17]:

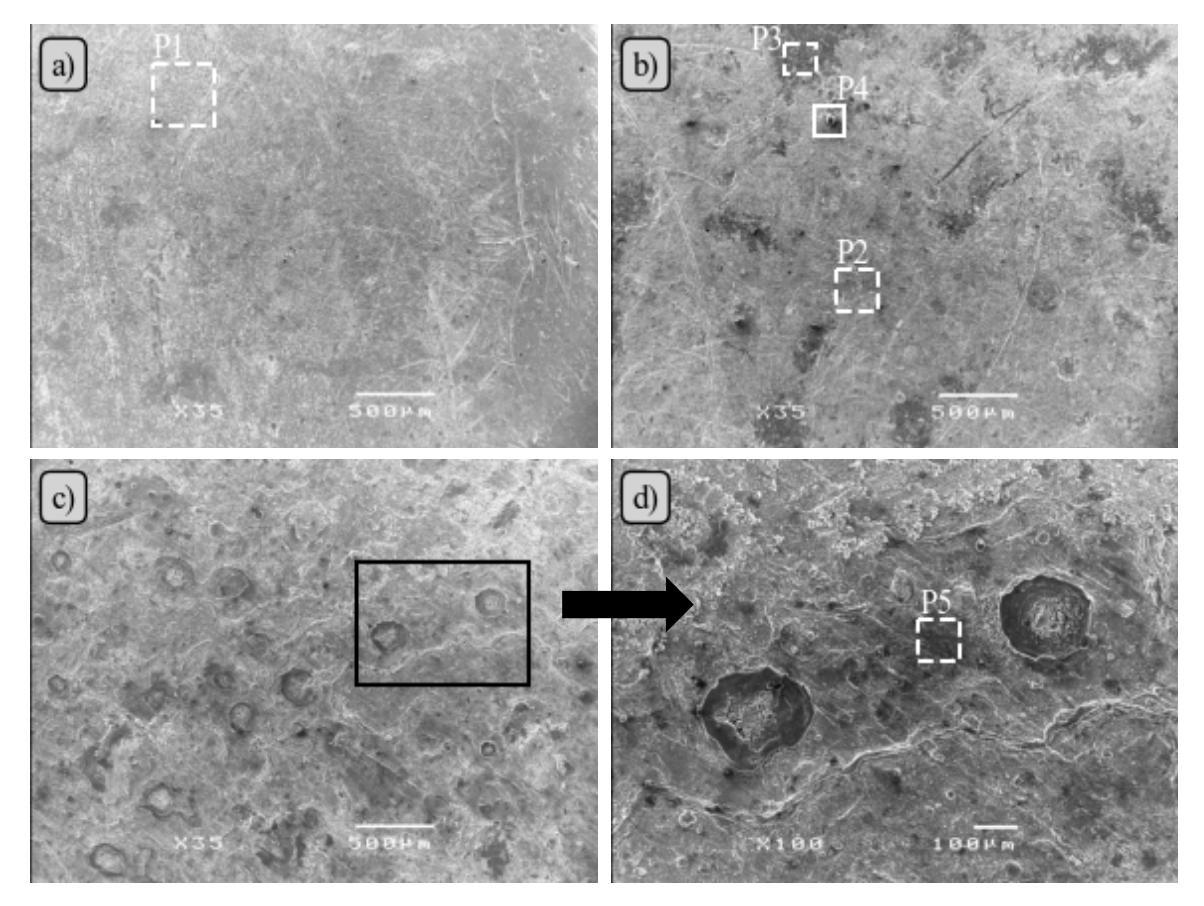
Figure 6. SEM images of surfaces of the galvanized steel samples exposed for 12 month at Saraburi (a), Chonburi, (b), and Songkhla (c), and (d).

Figure 6 shows the representatives of SEM images of the surfaces of the sample at Saraburi, Chonburi, and Songkhla together with EDS results in Table 5. The samples used were another cut of 20 mm  $\times$ 20 mm samples near the center of the original samples used for XRD experiments. Before cutting, the corroded samples were also covered with a plastic wrapper. According to the result, the sample exposed at Songkhla is the rustiest, followed by Chonburi and Saraburi. Conversely, the sample at Chonburi is the dirtiest as it is covered with a lot of pollutant particles. In the figure, EDS revealed the presence of the Fe element in them. Presumably, they are waste products released from factories and deposited on the sample surface. Dark patches were observed on the sample at Chonburi and Songkhla. EDS usually detects them containing high percentages of C compared to the general area. These areas have the potential to be the region of hydrozincite. Furthermore, XRD only detected hydrozincite as the only carbonate corrosion product on the samples. However, those areas are nonuniform, possibly because carbon dioxide gas diffused into dropletshaped moisture. At Songkhla, the sample was heavily pitted. Figure 7 provides a closer look at some pits on the sample surface. Judging from SEM images, they resemble a meteor crater of 100 µm in diameter. The structure of the pits was observed to be swelling on top of the coating surface first and later on sinking down in the middle and creating a meteor crater shape. In this research, the pit depth was not measured. Furthermore, they contained some spike ball structures in them. According to EDS, these spike ball structures are more likely to be pure zinc than a corrosion product due to a very high percentage of Zn. This evidence confirms that the pits are actually deep into the zinc coating surface rather than stopping at the corrosion product layer. However, the mechanism of the pit corrosion could not be discussed in this research as samples were not monitored often. Based on the result, the galvanized steel at Songkhla will undergo a local failure from the pit corrosion first rather than run out of the zinc coating.

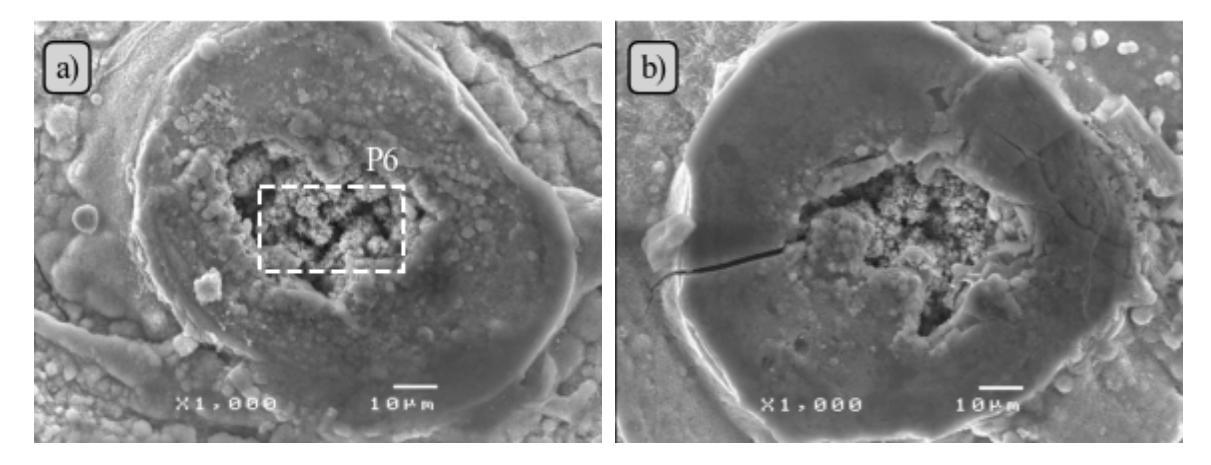
Figure 7. Meteor craters like pits on the surface of the galvanized steel sample exposed at Songkhla for 12 months.

3. Pits were observed only at Songkhla. They resembled a meteor crater. Moreover, they contained some spike ball structures, which appeared to be pure zinc.
